CALIFORNIA PEPPER TREES MAINTENANCE PLAN
HIGH STREET - MOORPARK, CALIFORNIA

1.1 SCOPE

This tree maintenance plan addresses a discrete collection of 50 California Pepper trees (*Schinus molle*) growing in portions of the public right-of-way along East High Street from its intersection with Moorpark Avenue to the 400 block of East High Street in Moorpark, California. Several of the trees may be remnants of an original planting at this location in the year 1900 by Robert Poindexter, a city founding father. The trees are included in Ventura County's Historical Landmark List. The purpose of this maintenance plan is to provide a realistic framework to accomplish an apparent dichotomy of needs: sustain the legacy of the original trees and deliver appropriate care to maximize the benefits of boulevard shade trees while minimizing increased risk to people and property as a result of their presence in this vital city corridor.

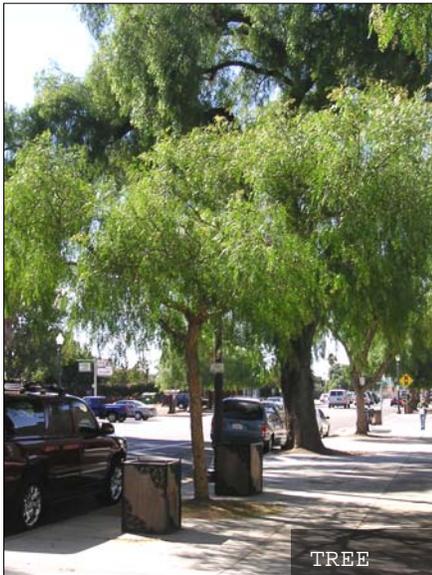
Tag/site #7 This 8-inch diameter tree is growing in a typically restricted growing space. The tree is established and requires routine maintenance treatments. Monitor the tree's progress; provide supplemental irrigation during periods of extended drought, as needed; provide routine pruning techniques as needed, direct the development of temporary major scaffold limbs on an east/west axis, prune to thin foliage on heavily laden limbs to avoid excessive strain, drooping, and possible breakage, avoid heading-back terminal ends and promote an upward growing canopy architecture, avoid over pruning the tree (remove up to or less than but no more than 20 percent of the live foliage).

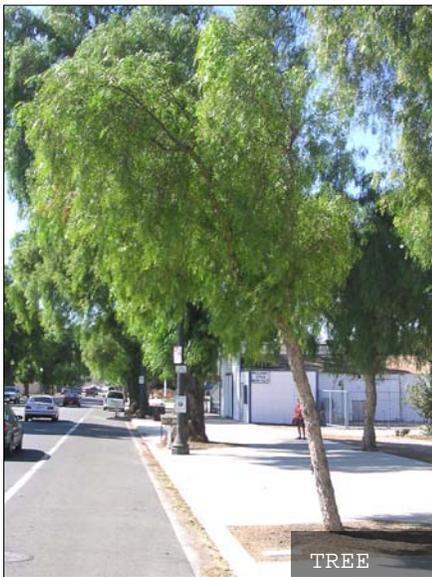
Tag/site #24 This 7-inch diameter tree is growing in a typically restricted growing space. The tree is established and requires routine maintenance treatments. The tree has developed with a pronounced lean to the south (toward High Street) resulting in disproportionate encroachment of the canopy into the roadway. Monitor the tree's progress; provide supplemental irrigation during periods of extended drought, as needed; provide crown reconstruction pruning techniques to counter canopy encroachment; provide routine pruning techniques as needed, direct the development of temporary major scaffold limbs on an east/west axis, prune to thin foliage on heavily laden limbs to avoid excessive strain, drooping, and possible breakage, avoid heading-back terminal ends and promote an upward growing canopy architecture, avoid over pruning the tree if possible but take necessary steps to redirect canopy development while maintaining tree health.

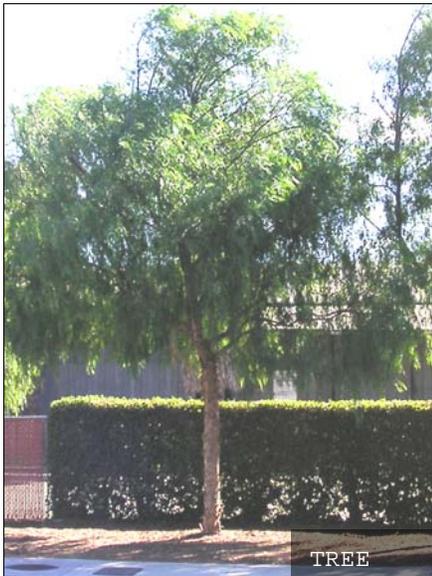
Tag/site #40 This 8-inch diameter tree is growing in a typically unrestricted growing space with a monolithic sidewalk and curb/gutter. The tree is established and requires routine maintenance treatments. The tree is situated in very close proximity to the adjacent tree (tagged #41) resulting in an inclusion of the two canopies. This tree has a dominant canopy at this time. Monitor the tree's progress; provide supplemental irrigation as needed; provide crown reconstruction pruning techniques to counter canopy encroachment, provide routine pruning techniques as needed, direct the development of temporary major scaffold limbs on an east/west axis, prune to thin foliage on heavily laden limbs to avoid excessive strain, drooping, and possible breakage, avoid heading-back terminal ends and promote an upward growing canopy architecture, avoid over pruning the tree if possible but take necessary steps to redirect canopy development while maintaining tree health.

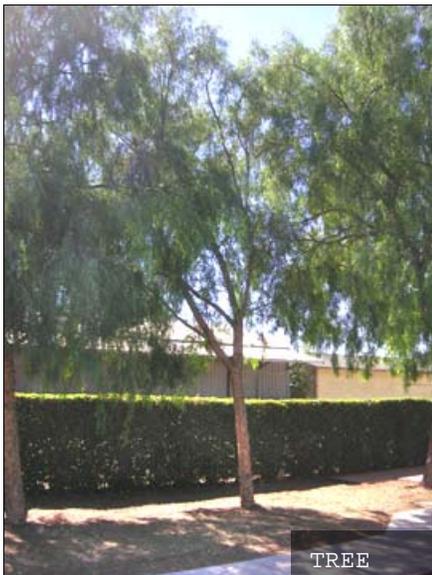
Tag/site #41 This 7-inch diameter tree is growing in a typically unrestricted growing space with a monolithic sidewalk and curb/gutter. The tree is established and requires routine maintenance treatments. The tree is situated in very close proximity to the adjacent trees (sites #40 and #42) and the canopies are impacting each other. This tree has a subordinate canopy at this time. Monitor the tree's progress; provide supplemental irrigation during periods of extended drought, as needed; provide crown reconstruction pruning techniques to promote development of adjacent tree's canopy; provide routine pruning techniques as needed, direct the development of temporary major scaffold limbs on an east/west axis, prune to thin foliage on heavily laden limbs to avoid excessive strain, drooping, and possible breakage, avoid heading-back terminal ends and promote an upward growing canopy architecture, avoid over pruning the tree (remove up to or less than but no more than 20 percent of the live foliage).

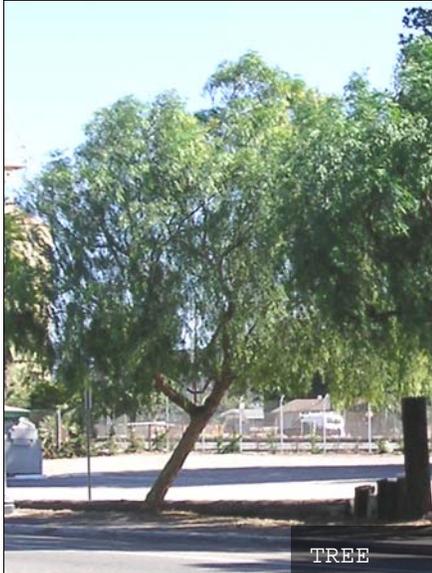
Tag/site #50 This 10-inch diameter tree is growing in an atypical growing space – it is set back about 2' from the monolithic boardwalk/sidewalk and a gravel/asphalt parking lot exists about 3' behind the tree; its canopy is restricted by an adjacent tree growing 25 feet to the west. The tree is established and requires routine maintenance treatments. The tree has developed with a pronounced lean to the west (toward tree tagged #51) resulting in an inclusion of the two canopies. Neither tree is subordinated at this time. Monitor the tree's progress; provide supplemental irrigation as needed; provide crown reconstruction pruning techniques to counter canopy encroachment, provide routine pruning techniques as needed, direct the development of temporary major scaffold limbs on an east/west axis, prune to thin foliage on heavily laden limbs to avoid excessive strain, drooping, and possible breakage, avoid heading-back terminal ends and promote an upward growing canopy architecture, avoid over pruning the tree if possible but take necessary steps to redirect canopy development while maintaining tree health.

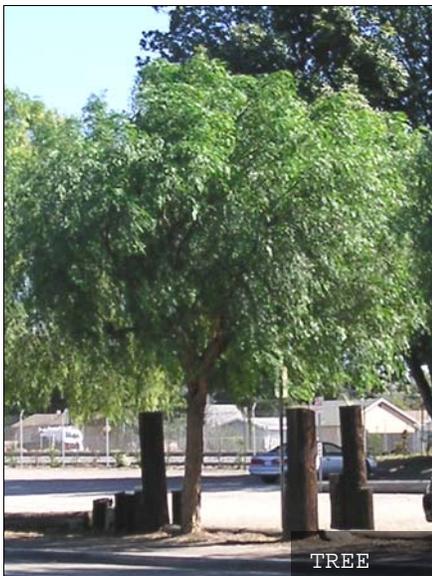
Tag/site #51 This 10-inch diameter tree is growing in an atypical growing space – it is set back about 2' from the monolithic boardwalk/sidewalk and a gravel/asphalt parking lot exists about 3' behind the tree; its canopy is restricted by adjacent trees growing 23 feet to the west and 25 feet to the east. The tree is established and requires routine maintenance treatments. Adjacent trees on each side are situated in very close proximity to this tree resulting in an inclusion of the three canopies. None of these trees are subordinated at this time. Monitor the tree's progress; provide supplemental irrigation as needed; provide crown reconstruction pruning techniques to counter canopy encroachment, provide routine pruning techniques as needed, direct the development of temporary major scaffold limbs on an east/west axis, prune to thin foliage on heavily laden limbs to avoid excessive strain, drooping, and possible

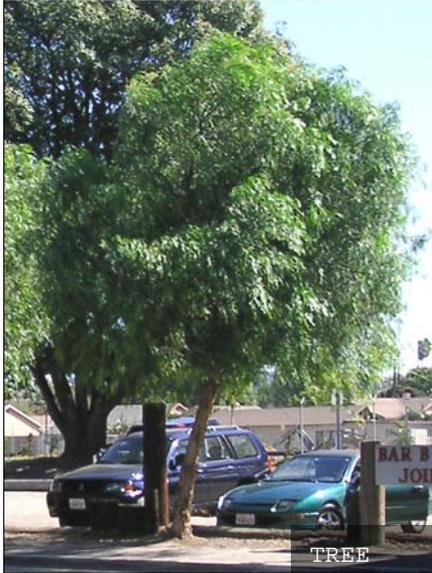
Tag/site #52 This 7-inch diameter tree is growing in an atypical growing space – it is set back about 2' from the monolithic boardwalk/sidewalk and a gravel/asphalt parking lot exists about 3' behind the tree; its canopy is restricted by an adjacent tree growing 23 feet to the east. The tree is established and requires routine maintenance treatments. The tree has developed with a pronounced lean to the west and their canopies are growing toward each other. Neither tree is subordinated at this time. There is a wire girdling the trunk about 7 feet up from grade – this restrictive device must be removed at the earliest opportunity. Monitor the tree's progress; provide supplemental irrigation as needed; provide crown reconstruction pruning techniques to counter canopy encroachment, provide routine pruning techniques as needed, direct the development of temporary major scaffold limbs on an east/west axis, prune to thin foliage on heavily laden limbs to avoid excessive strain, drooping, and possible breakage, avoid heading-back terminal ends and promote an upward growing canopy architecture, avoid over pruning the tree if possible but take necessary steps to redirect canopy development while maintaining tree health.

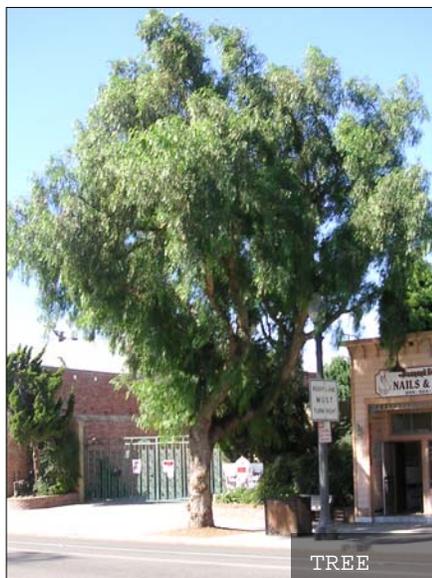
Tag/site #2 This 21-inch diameter tree is growing in a typically restricted growing space with a park-style bench located about 10 feet north of the planting site. The tree has a canopy that extends about 35 feet high and 25 feet wide. One or more of the primary scaffold limbs are oriented toward the east and originate from the main stem about 8 feet up from grade. Monitor the tree's stability on a routine basis (at least annually and at times of inclement weather); provide crown reconstruction pruning techniques to improve scaffold branch attachment and arrangement, provide routine pruning techniques as needed, prune to provide adequate clearance for vehicular traffic on High Street and

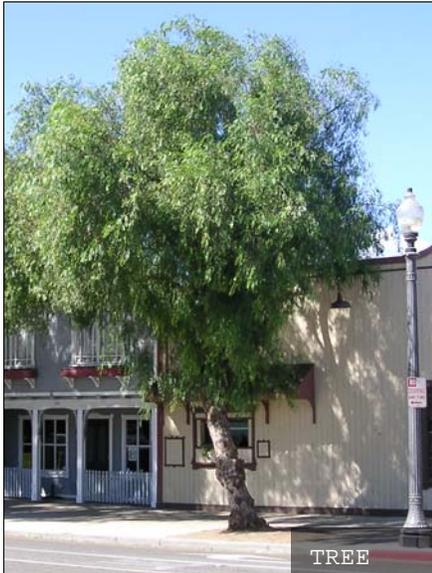
Tag/site #3 This 19-inch diameter tree is growing in a typically restricted growing space. The tree has a canopy that extends about 40 feet high and as wide. The main scaffold limbs are well distributed to support the canopy architecture; the lowest one originates about 8 feet up from grade. Monitor the tree's stability on a routine basis; provide routine pruning techniques as needed, prune to maintain adequate clearance for vehicular traffic on High Street and pedestrian traffic along the sidewalk, prune to thin foliage on heavily laden limbs to avoid excessive strain, drooping, and possible breakage, avoid heading-back terminal ends and promote an upward growing canopy architecture, avoid over pruning the tree (remove up to or less than but no more than 20 percent of the live foliage).

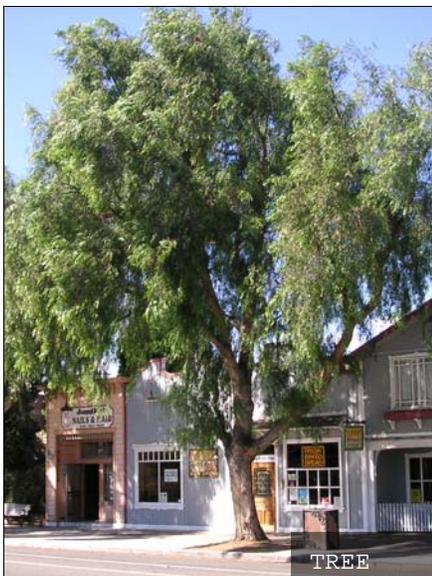
Tag/site #4 This 15-inch diameter tree is growing in a typically restricted growing space. The tree has a canopy that extends about 30 feet high and 25 feet wide. The main stem leans to the west and its dense canopy has regenerated from a branch architecture altered by severe pruning. Monitor the tree's stability on a routine basis; provide crown reconstruction pruning techniques to improve scaffold branch attachment and arrangement, provide routine pruning techniques as needed, prune to provide adequate clearance for vehicular traffic on High Street and pedestrian traffic along the sidewalk, prune to thin foliage on heavily laden limbs to avoid excessive strain, drooping, and possible breakage, avoid heading-back terminal ends and promote an upward growing canopy architecture, avoid over pruning the tree if

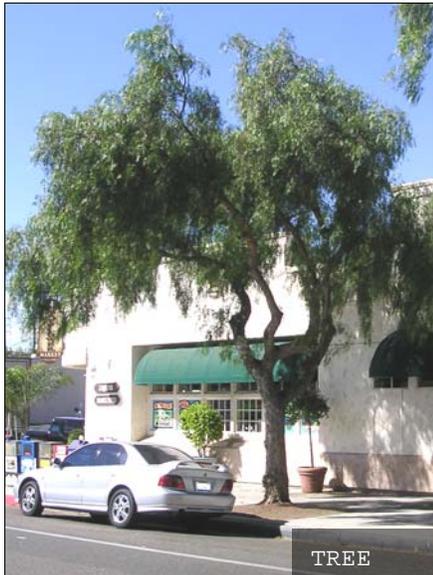
Tag/site #5 This 14-inch diameter tree is growing in a typically restricted growing space. The tree has a canopy that extends about 35 feet high and as wide. The tree was somewhat over pruned previously and the main scaffold limbs originate low in the canopy architecture; the lowest major scaffold limb bifurcates from the stem about 6 feet up from grade and the canopy is raised high and distributed among four roughly co-dominant scaffolds that are oriented on an east/west axis. Monitor the tree's stability on a routine basis; provide crown reconstruction pruning to promote branch develop lower in the canopy, provide routine pruning techniques as needed, prune to maintain adequate clearance for vehicular traffic on High Street and pedestrian traffic along the sidewalk, prune to thin foliage on heavily laden limbs to avoid excessive strain, drooping, and possible breakage, avoid heading-back terminal ends and promote an upward growing canopy architecture, avoid over pruning the tree if possible but take necessary steps to redirect canopy development while maintaining tree health.

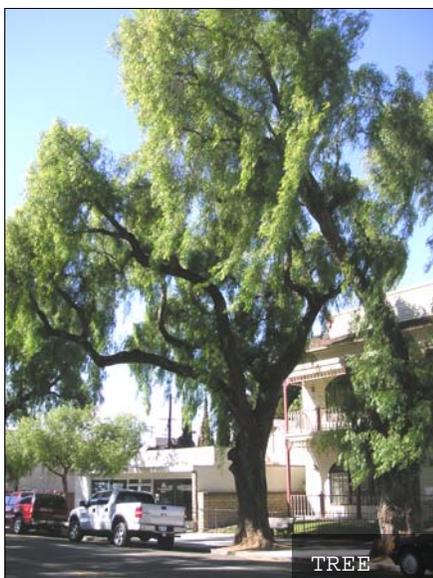
Tag/site #8 This 38-inch diameter tree is growing in a typically restricted growing space with a park-style bench located about 10 feet northwest of the planting site. The tree has a canopy that extends about 50 feet high and 60 feet wide. Initial stem bifurcation occurs about 10 feet up, progressive branching of primary and secondary scaffold limbs occurs throughout the canopy promoting a well distributed branch architecture. Several of the scaffold limbs are long and horizontal and tend to be heavily loaded toward branch ends. Monitor the tree's stability on a routine basis; provide crown reconstruction pruning techniques along the long horizontal limbs to promote branch development and architectural structure closer toward the main stem, provide routine pruning

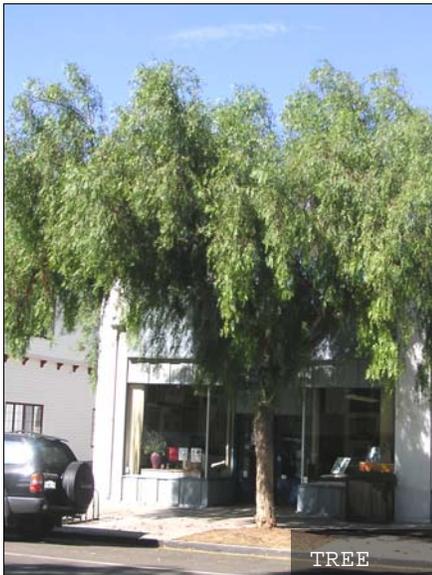
Tag/site #10 This 12-inch diameter tree is growing in a typically restricted growing space. It does not have a number tag attached to the trunk at this time. The tree has a canopy that extends about 25 feet high and 35 feet wide. Multiple primary scaffold limbs originate from the main stem about 8 feet up from grade with a horizontal orientation. Monitor the tree's stability on a routine basis; provide crown reconstruction pruning techniques to improve scaffold branch attachment and arrangement, provide routine pruning techniques as needed, prune to provide adequate clearance for vehicular traffic on High Street and pedestrian traffic along the sidewalk, prune to thin foliage on heavily laden limbs to avoid excessive strain, drooping, and possible breakage, avoid heading-back terminal ends and promote an upward growing canopy architecture, avoid over pruning the tree if possible but take necessary steps to redirect canopy development while maintaining tree health.

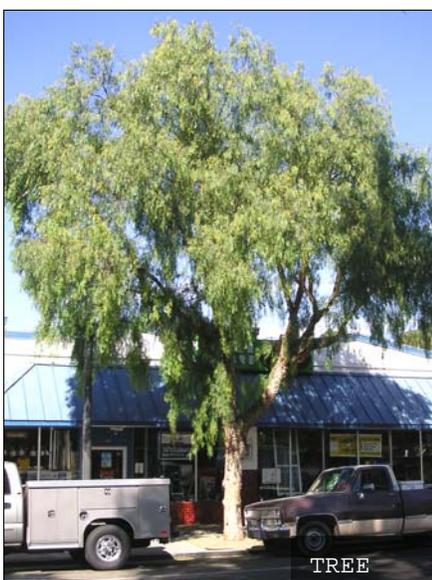
Tag/site #11 This 15-inch diameter tree is growing in a typically restricted growing space. It does not have a number tag attached to the trunk at this time. The tree has a canopy that extends about 35 feet high and as wide. Initial stem bifurcation occurs about 8 feet up, progressive branching of primary and secondary scaffold limbs occurs throughout the canopy promoting a well distributed branch architecture. Monitor the tree's stability on a routine basis; provide routine pruning

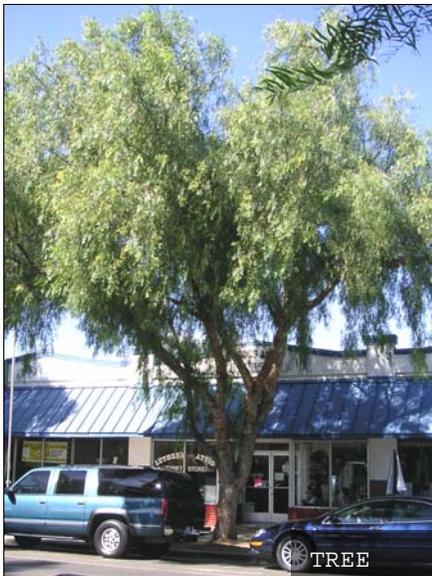
Tag/site #12 This 18-inch diameter tree is growing in a typically restricted growing space. It does not have a number tag attached to the trunk at this time. The tree has a canopy that extends about 35 feet high and 40 feet wide. Initial stem bifurcation occurs about 6 feet up, progressive branching of primary scaffold limbs with sharp-angled crotches occurs throughout the canopy. Monitor the tree's stability on a routine basis with particular emphasis on the attachment of limbs with sharp-angled crotches; provide crown reconstruction pruning techniques to improve scaffold branch attachment and arrangement, provide routine pruning techniques as needed, prune to maintain adequate clearance for vehicular traffic on High Street and pedestrian traffic along the sidewalk, prune to thin foliage on heavily laden limbs to avoid excessive strain, drooping, and possible breakage, avoid heading-back terminal ends and promote an upward growing canopy architecture, avoid over pruning the tree if possible but take necessary steps to redirect canopy development while maintaining tree health.

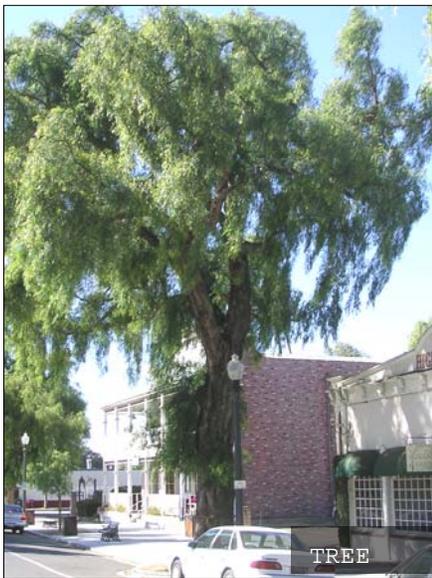
Tag/site #16 This 39-inch diameter tree is growing in a modified typically restricted growing space – the planter pops out into the roadway a distance of about 4 feet. The tree has a canopy that extends about 50 feet high and 60 feet wide. Initial stem bifurcation occurs about 20 feet up, progressive branching of primary and secondary scaffold limbs occurs throughout the canopy producing an especially high canopy architecture. Several of the scaffold limbs are long and horizontal and tend to be heavily loaded toward branch ends. Monitor the tree's stability on a routine basis; provide crown reconstruction pruning techniques along the long horizontal limbs to promote branch development and architectural structure closer toward the main stem, provide routine pruning techniques as needed, prune to maintain adequate clearance for vehicular traffic on High Street and pedestrian traffic along the sidewalk but, over time, develop well placed new sprouts to extend canopy architecture lower on the stem, prune to thin foliage on heavily laden limbs to avoid excessive strain, drooping, and possible breakage, routinely reduce horizontal canopy expansion by selectively cutting back terminal ends to appropriate-sized and well-placed lateral branches, avoid over pruning the tree (remove up to or less than but no more than 20 percent of the live foliage).

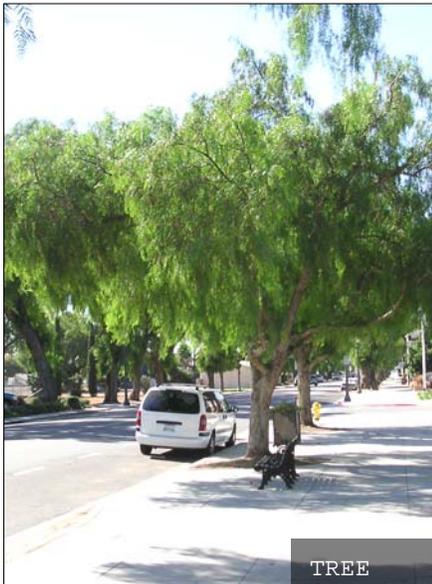
Tag/site #20 This 17-inch diameter tree is growing in a typically restricted growing space. The tree has a canopy that extends about 25 feet high and as wide. Initial stem bifurcation occurs about 8 feet up, progressive branching of primary and secondary scaffold limbs occurs throughout the canopy promoting a well distributed branch architecture. Removal of one or more low horizontal limbs may improve the canopy form and reduce long-term pedestrian clearance requirements. Monitor the tree's stability on a routine basis; provide routine pruning techniques as needed, prune to provide adequate clearance for vehicular traffic on High Street and pedestrian traffic long the sidewalk, prune to thin foliage on heavily laden limbs to avoid excessive strain, drooping, and possible breakage, avoid heading-back terminal ends and promote an upward growing canopy architecture, avoid over pruning the tree (remove up to or less than but no more than 20 percent of the live foliage).

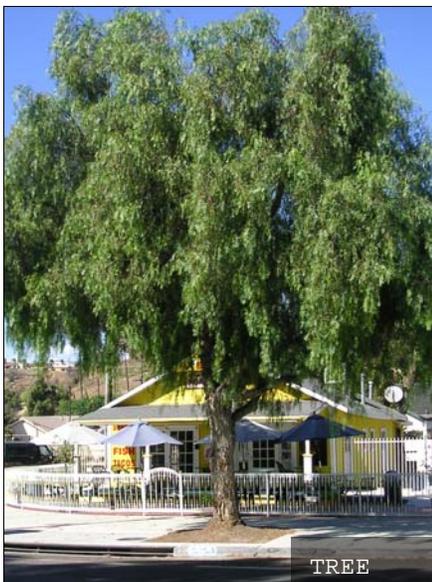
Tag/site #21 This 23-inch diameter tree is growing in a typically restricted growing space with a park-style bench located about 10 feet east of the planting site. The tree has a canopy that extends about 20 feet high and 30 feet wide. Initial stem bifurcation occurs about 6 feet up with multiple primary scaffold limbs originating low on the main stem and extending along a horizontal angle. Monitor the tree's stability on a routine basis, especially sections that extend over (and therefore tend to threaten) the vicinity of the park bench; provide crown reconstruction pruning techniques to improve scaffold branch attachment and arrangement, provide routine pruning techniques as needed, prune to provide adequate clearance for vehicular traffic on High Street and pedestrian traffic along the sidewalk, prune to thin foliage on heavily laden limbs to avoid excessive strain, drooping, and possible breakage, avoid heading-back terminal ends and promote an upward growing canopy architecture, avoid over pruning the tree if possible but

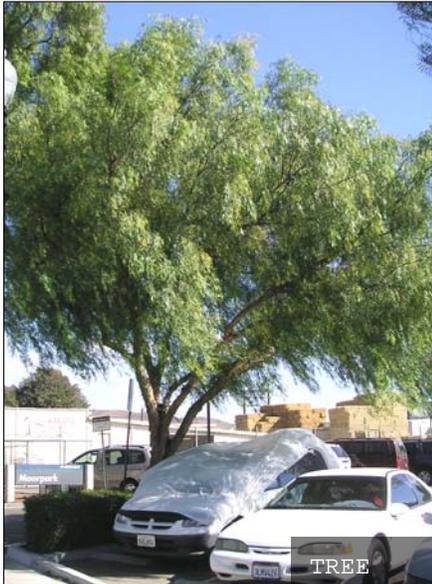
Tag/site #27 This 15-inch diameter tree is growing in an atypical growing space that is 15 feet deep but only 5 feet wide. The tree has developed with a pronounced lean to the south; its canopy extends about 20 feet high and 25 feet wide. Initial stem bifurcation occurs about 4 feet up with multiple primary scaffold limbs originating with narrow crotch angles, low on the main stem, and extending along a low, horizontal angle. Monitor the tree's stability on a routine basis, especially sections that extend over (and therefore tend to threaten) the vicinity of the parking lot; provide crown reconstruction pruning techniques to improve scaffold branch attachment and arrangement, provide routine pruning techniques as needed, prune to provide adequate clearance for vehicular and pedestrian traffic, prune to thin foliage on heavily laden limbs to avoid excessive strain, drooping, and possible breakage, avoid heading-back terminal ends and promote an upward growing canopy architecture, avoid over pruning the tree if possible but take necessary steps to redirect canopy development while maintaining tree health.

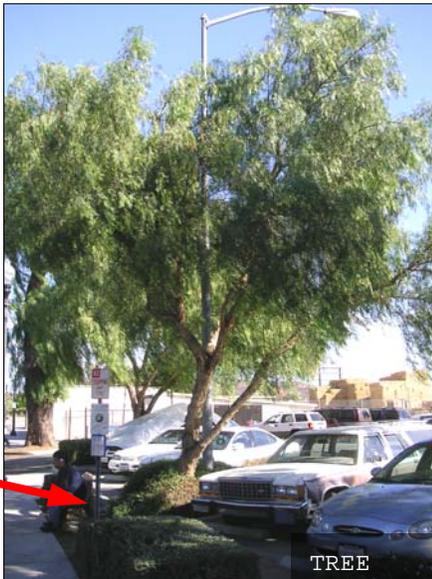
Tag/site #28 This 11-inch diameter tree is growing in an atypical growing space that is 9 feet wide but the trunk is only 1 foot west and 2 feet south of pavement edges. Large surface roots (6-inches in diameter and 4-inches in diameter – see detail photo) have been cut on the north side, behind the direction of the tree's lean, to avert encroachment with adjacent pavement. This treatment tends to destabilize the tree. The tree has one low horizontal scaffold limb extending to the south; its canopy, 20-foot high and as wide, is otherwise symmetrical. Monitor the tree's stability on a routine basis, especially sections that extend over (and therefore tend to threaten) the vicinity of the parking lot; provide pruning treatments to remove the low branch and

improve the branch distribution, provide routine pruning techniques as needed, prune to provide adequate clearance for vehicular and pedestrian traffic, prune to thin foliage on heavily laden limbs to avoid excessive strain, drooping, and possible breakage, avoid heading-back terminal ends and promote an upward growing canopy architecture, avoid over pruning the tree if possible but take necessary steps to redirect canopy development while maintaining tree health. When the opportunity arises to replace the tree the new specimen should be centered in the growing space.

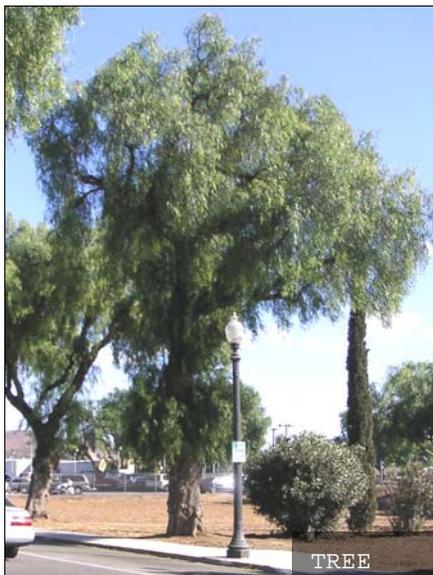
Tag/site #35 This 32-inch diameter tree is growing in a typically unrestricted growing space with a monolithic sidewalk and curb/gutter. The tree has a canopy that extends about 30 feet high and 60 feet wide. Initial stem bifurcation occurs about 20 feet up, progressive branching of primary and secondary scaffold limbs occurs throughout the canopy producing an especially high canopy architecture. Several of the scaffold limbs are long and horizontal and tend to be heavily loaded toward branch ends. Monitor the tree's stability on a routine basis; provide crown reconstruction pruning techniques along the long horizontal limbs to promote branch development and architectural structure closer toward the main stem, provide routine pruning techniques as needed, prune to maintain adequate clearance for vehicular traffic on High Street and pedestrian traffic along the sidewalk but, over time, develop well placed new sprouts to extend canopy architecture lower on the stem, prune to thin foliage on heavily laden limbs to avoid excessive strain, drooping, and possible breakage, routinely reduce horizontal canopy expansion by selectively cutting back terminal ends to appropriate-sized and well-placed lateral branches, avoid over pruning the tree (remove up to or less than but no more than 20 percent of the live foliage).

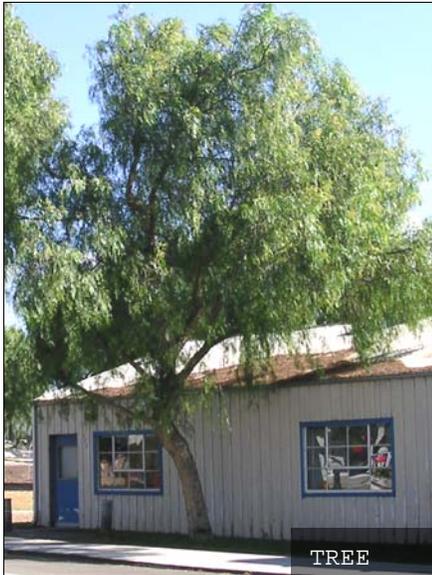
Tag/site #37 This 13-inch diameter tree is growing in an atypical growing space with 9 feet between a building and the monolithic sidewalk. Additionally, the space is essentially unlimited in its width. The tree has developed with a pronounced lean to the north, away from the building. The tree has one low horizontal scaffold limb extending to the north; its canopy, 20 feet high and as wide, would otherwise be symmetrical. Monitor the tree's stability on a routine basis, especially the impact of and potential pressure from the root zone as it develops in the vicinity of the adjacent building; provide pruning treatments to remove the low branch and improve the branch distribution, provide routine pruning techniques as needed, prune to provide adequate clearance for vehicular and pedestrian traffic, prune to thin foliage on heavily laden limbs to avoid excessive strain, drooping, and possible breakage, avoid heading-back terminal ends and promote an upward growing canopy architecture, avoid over pruning the tree if possible but take necessary steps to redirect canopy development while maintaining tree health.

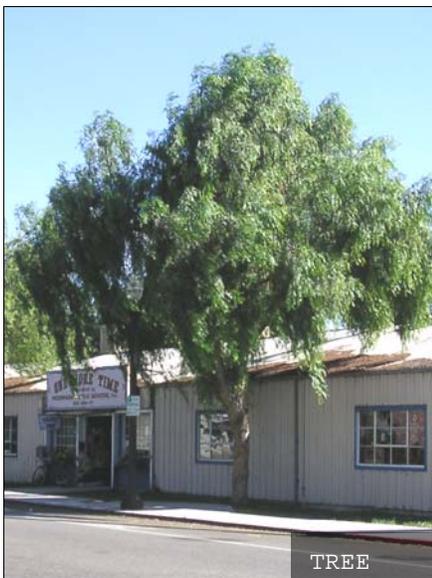
Tag/site #38 This 14-inch diameter tree is growing in an atypical growing space that is 5 feet deep – the tree trunk abuts a sidewalk section extended into the planter to accommodate an ornamental street lamppost. Imminent conflict is likely with the adjacent meandering sidewalk. Monitor the tree's stability and its impact on adjacent structure and infrastructure; provide routine pruning techniques as needed, prune to maintain adequate clearance for vehicular and pedestrian traffic and clearance from the building roof, prune to thin foliage on heavily laden limbs to avoid excessive strain, drooping, and possible breakage, avoid heading-back terminal ends and promote an upward growing canopy architecture, avoid over pruning the tree (remove up to or less than but no more than 20 percent of the live foliage). When an opportunity arises to replace the tree the new specimen should be accommodated by the growing space.

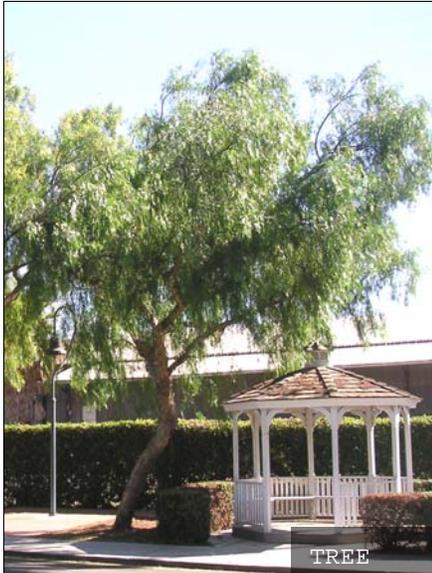
Tag/site #42 This 11-inch diameter tree is growing in an atypical growing space 4 feet east of brick paving (on the west side) and the tree's stem is 3 feet south of the sidewalk on the north side, which was extended to allow pedestrians to meander around an ornamental street lamppost. A potential future encroachment conflict is likely with the adjacent paved surfaces. The tree has a low, horizontal canopy architecture that extends about 18 feet above ground and westward, somewhat toward the gazebo. Monitor the tree's stability and its impact on adjacent structure and infrastructure; provide crown reconstruction pruning techniques along the long horizontal limbs to promote branch development and architectural structure closer toward the main stem, provide routine pruning techniques as needed, prune to maintain adequate clearance for vehicular and pedestrian traffic and clearance from the gazebo, prune to thin foliage on heavily laden limbs to avoid excessive strain, drooping, and possible breakage, avoid heading-back terminal ends and promote an upward growing canopy architecture, avoid over pruning the tree if possible but take necessary steps to redirect canopy development while maintaining tree health.

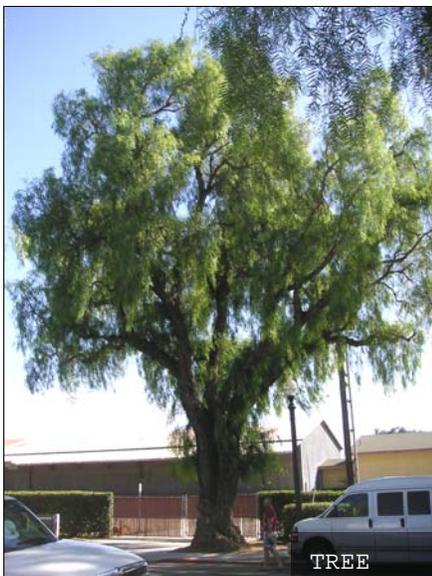
Tag/site #43 This 42-inch diameter tree is growing in an atypical growing space – and potential conflict is likely with the adjacent paved surfaces. Additional conflicts are likely with high voltage utility power lines that run along the south side of the tree. The tree has a canopy that extends about 40 feet high and 55 feet wide. Due to the phototropism and its effect on plant growth, portions of the tree canopy will have an inclination to encroach into the vicinity of these energized conductors. Unless maximum clearance standards are met, clearance pruning will occur by agents of the utility company and the interests of the tree will be secondary at best. (Utility line clearance is conducted in accordance with requirements of General Order 95, Rule 35 of The California Public Utilities Commission). Initial stem

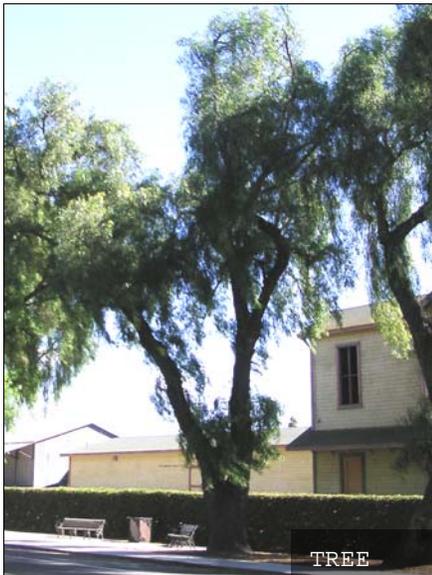
Tag/site #46 This 41-inch diameter tree is growing in a typically unrestricted growing space with a monolithic sidewalk and curb/gutter, though there is a concrete pad with a park bench a short distance to the east of the tree base. Other potential conflicts are possible with high voltage utility power lines that run along the south side of the tree. The tree has a canopy that extends about 50 feet high and 50 feet wide. This tree has a co-dominant stem architecture and initial stem bifurcation occurs about 6 feet up. Lateral branching secondary scaffold limbs occurs high in the canopy resulting in severe canopy architecture. Several of the secondary scaffold limbs are long and horizontal, and may develop a tendency to become overloaded toward branch ends. Monitor the tree's stability on a routine basis; provide crown reduction pruning techniques along the long horizontal limbs to promote branch development and architectural structure closer toward the main stem,

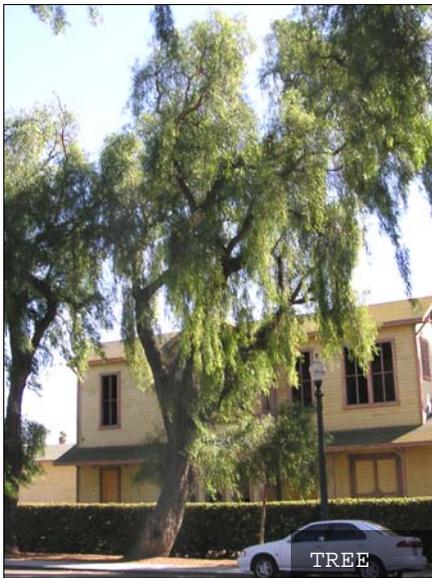
Tag/site #47 This 40-inch diameter tree is growing in a typically unrestricted growing space with a monolithic sidewalk and curb/gutter, though the adjacent tree (#46) is growing with its trunk only 20 feet away to the east and high voltage utility power lines run along the south side of the tree. The tree's canopy extends about 50 feet high and as wide. The tree leans to the south and little of its canopy architecture extends to the north or to the east. Lateral limbs extending to the south have been truncated due to the high voltage utility lines. Additionally, a new tree has been installed adjacent and to the west, also about 20 feet away. The canopy of this tree must be modified over time if the small new tree is to develop its full form. Monitor the tree's stability on a routine basis; provide crown reconstruction pruning techniques on the north and south side to promote lateral branching and natural branch structure, provide crown reduction pruning techniques on the west side to provide solar radiation exposure for the adjacent new tree, provide routine pruning techniques as needed, prune to thin foliage on heavily laden limbs to avoid excessive strain, drooping, and possible breakage, routinely reduce horizontal canopy expansion by selectively cutting back terminal ends to appropriate-sized and well-placed lateral branches, avoid over pruning the tree (remove up

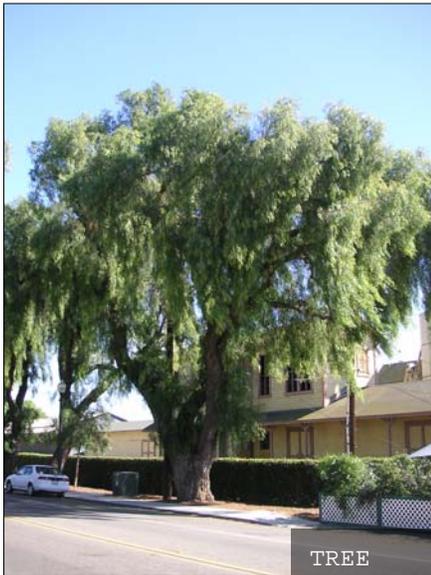
Tag/site #49 This 51-inch diameter tree is growing in a typically unrestricted growing space with a monolithic sidewalk and curb/gutter. The tree's canopy extends about 50 feet high and 70 feet wide. Three primary scaffold limbs bifurcate from the stem about 6 feet above grade and triangulate in such a fashion as to avoid the vicinity of power lines that run along the south side of the tree. A utility pole and associated communications lines are located beneath and extending through the canopy; this infrastructure has minor relevance to tree maintenance. Monitor the tree's stability on a routine basis; provide crown reconstruction pruning techniques along the long horizontal limbs to promote branch development and architectural structure closer toward the main stem, provide routine pruning techniques as needed, prune to maintain adequate clearance for vehicular traffic on High Street, prune to thin foliage on heavily laden limbs to avoid excessive strain, drooping, and possible breakage, routinely reduce horizontal canopy expansion by selectively cutting back terminal ends to appropriate-sized and well-placed lateral branches, avoid over pruning the tree (remove up to or less than but no more than 20 percent of the live foliage).

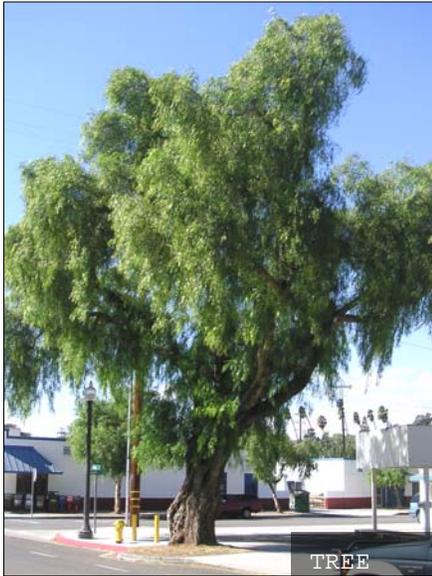
Tag/site #13 This 43-inch diameter tree is growing in a modified typically restricted growing space – the planter pops out into the roadway a distance of about 4 feet. Previous assessments indicate major problems with both root stability and scaffold stability, and extreme problems related to a large trunk cavity and decay. The tree has a pronounced lean to the north and has a canopy extending about 40 feet high and 60 feet wide. The initial stem bifurcation is about 10 feet up with 5 primary scaffold limbs and progressive branching of secondary scaffold and smaller branches and twigs throughout the canopy. Each of the scaffold limbs is long and horizontal and tends to be heavily loaded toward branch ends. Initiate extensive crown reconstruction pruning on an annual schedule for a minimum of 5 years; progressively reduce the length of long vertical and horizontal limbs each year to gradually promote branch development and architectural structure closer toward the main stem, delay other routine pruning techniques until crown reconstruction is well underway, safety prune to maintain adequate clearance for vehicular traffic on High Street and pedestrian traffic along the sidewalk but, over time, develop well placed new sprouts to extend canopy architecture lower on the stem.

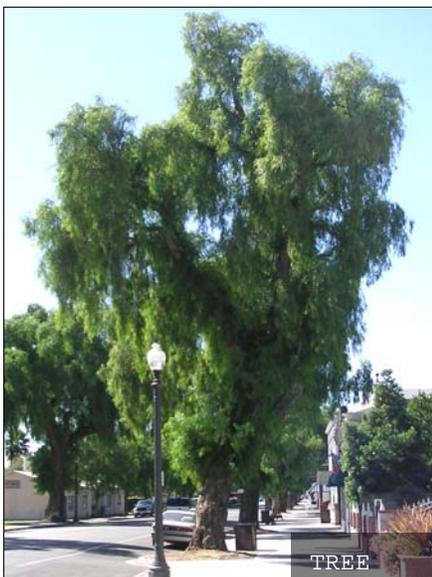
Tag/site #17 This 41-inch diameter tree is growing in a modified typically restricted growing space – the planter pops out into the roadway a distance of about 4 feet. Previous assessments indicate extreme problems with roots stability and trunk stability and major problems with the health of the roots. This tree's condition warrants ongoing consideration for its useful contribution to the grove. The tree's canopy extends about 50 feet high and 44 feet wide. The one large lateral limb originates about 8 feet up from grade; it is truncated about 10 above its point of origination. The primary

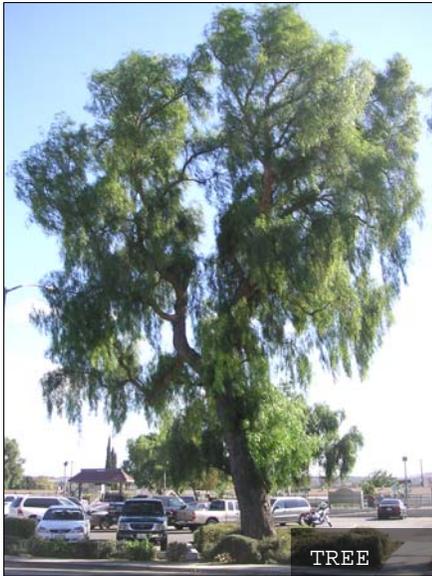
Tag/site #30 This 37-inch diameter tree is growing in an atypical growing space – 19 feet wide and 26 feet deep, with a monolithic sidewalk and curb/gutter. Previous assessments indicate major problems with the health and stability of the trunk and the scaffold limbs. The tree's canopy extends about 40 feet high and 47 feet wide. The initial stem bifurcation is about 15 feet up, with 3 primary scaffold limbs and secondary scaffold and smaller branches and twigs throughout the canopy. Several of the major lateral limbs are long, horizontal, and tend to be heavily loaded toward branch ends. Initiate extensive crown reconstruction pruning on an annual schedule for a minimum of 5 years; progressively reduce the length of long vertical and horizontal limbs each year to gradually promote branch development and architectural structure closer toward the main stem, delay other routine pruning techniques until crown reconstruction is well underway, safety prune to maintain adequate clearance for vehicular and pedestrian traffic.

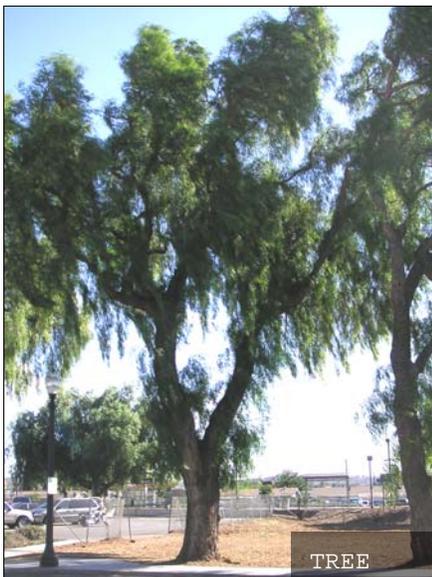
Tag/site #31 This 36-inch diameter tree is growing in a typically unrestricted growing space with a monolithic sidewalk and curb/gutter. Previous assessments indicate major problems with the health and stability of the trunk and the stability of scaffold limbs. The tree's canopy extends about 35 feet high and 52 feet wide. This tree has a co-dominant stem architecture and initial stem bifurcation occurs about 8 feet up. Lateral primary scaffold limbs occur high in the canopy resulting in an elevated canopy form. Initiate extensive crown reconstruction pruning on an annual schedule for a minimum of 5 years; progressively reduce the length of long vertical and horizontal limbs each year to gradually promote branch development and architectural structure closer toward the main stem, delay other routine pruning techniques until crown reconstruction is well underway, safety prune to maintain adequate clearance for vehicular and pedestrian traffic but, over time, develop well placed

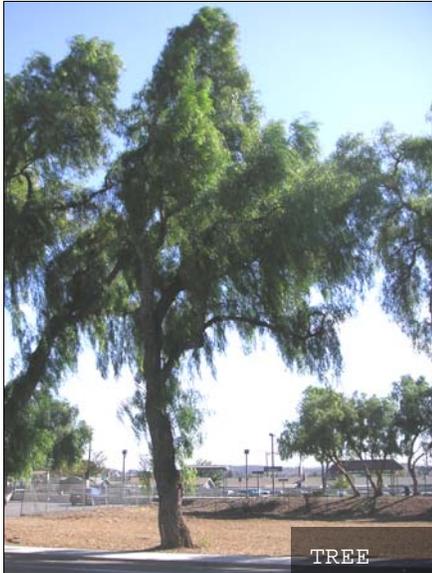
Tag/site #32 This 25-inch diameter tree is growing in a typically unrestricted growing space with a monolithic sidewalk and curb/gutter. Previous assessments indicate extreme problems with root stability and major problems with trunk and scaffold stability and scaffold health. The tree's canopy extends about 30 feet high and 43 feet wide with most of the canopy on a north south axis due to its close proximity to an adjacent tree (#31). The main stem bifurcation is about 15 feet up. Initiate extensive crown reconstruction pruning on an annual schedule for a minimum of 5 years; progressively reduce the length of long vertical and horizontal limbs each year to gradually promote branch development and architectural structure closer toward the main stem, delay other routine pruning techniques until crown reconstruction is well underway, safety prune to maintain adequate clearance for vehicular and pedestrian traffic but, over time, develop well placed new sprouts to extend canopy architecture lower on the stem.

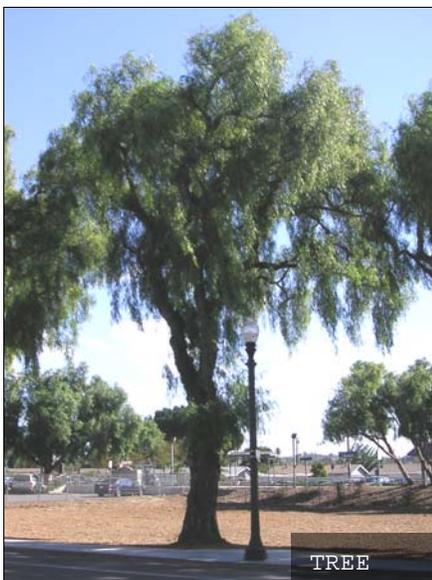
Tag/site #33 This 30-inch diameter tree is growing in a typically unrestricted growing space with a monolithic sidewalk and curb/gutter. Previous assessments indicate major problems with root stability. The tree's canopy extends about 30 feet high and 39 feet wide. This tree has a co-dominant stem architecture and initial stem bifurcation occurs about 15 feet up. Lateral primary scaffold limbs occur high in the canopy resulting in an elevated canopy form. Initiate extensive crown reconstruction pruning on an annual schedule for a minimum of 5 years; progressively reduce the length of long vertical and horizontal limbs each year to gradually promote branch development and architectural structure closer toward the main stem, delay other routine pruning techniques until crown reconstruction is well underway, safety prune to maintain adequate clearance for vehicular

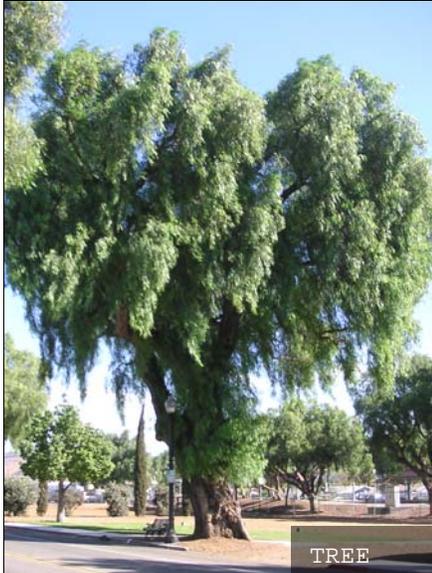
Tag/site #36 This 59-inch diameter tree is growing in a typically unrestricted growing space with a meandering sidewalk, placing the tree in an open space between the sidewalk and High Street. A park bench is located on the north side between the tree and High Street, directly under the lean. Previous assessments indicate extreme problems with root health, major problems with root stability and scaffold limb stability, and due to a large cavity and decay major problems with the trunk health. The tree's canopy extends about 45 feet high and 66 feet wide. This tree has a co-dominant stem architecture and initial stem bifurcation occurs about 15 feet up. Lateral primary scaffold limbs occur high in the canopy resulting in an elevated canopy form. The initial stem bifurcation is about 10 feet up with additional bifurcation of scaffold limbs about 5 feet higher. Many of the scaffold limbs are long and horizontal and tend to be heavily loaded toward branch ends. Remove the park bench away from this location and relocate it where it will not present a potential high risk for damage or injury in case of tree failure. Initiate extensive crown reconstruction pruning on an annual schedule for a minimum of 5 years; progressively reduce the length of long vertical and horizontal limbs each year to gradually promote branch development and architectural structure closer toward the main stem, delay other routine pruning techniques until crown reconstruction is well underway, safety prune to maintain adequate clearance for vehicular and pedestrian traffic but, over time, develop well placed new sprouts to extend canopy architecture lower on the stem.

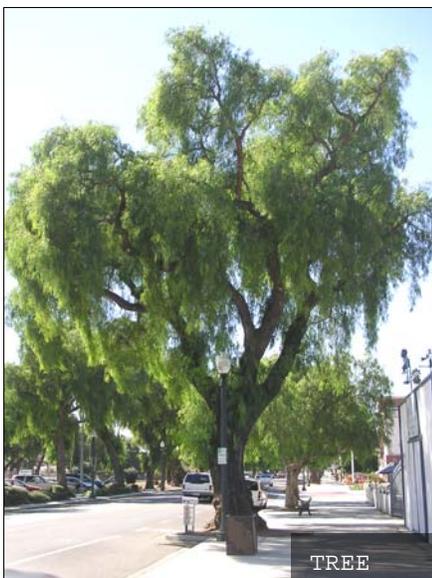
Tag/site #22 This 48-inch diameter tree is growing in a modified typically restricted growing space – the planter pops out into the roadway a distance of about 4 feet. The tree has a canopy that extends about 45 feet high and 53 feet wide. Previous assessments indicate extreme problems with root stability, trunk stability, and scaffold limb stability and the tree has a severe lean to the west. Due to conditions of instability that cannot be mitigated the tree should be removed at the earliest opportunity, the site should be prepared for replanting and a new tree should be installed at this location. Please see planting specifications, enclosed.

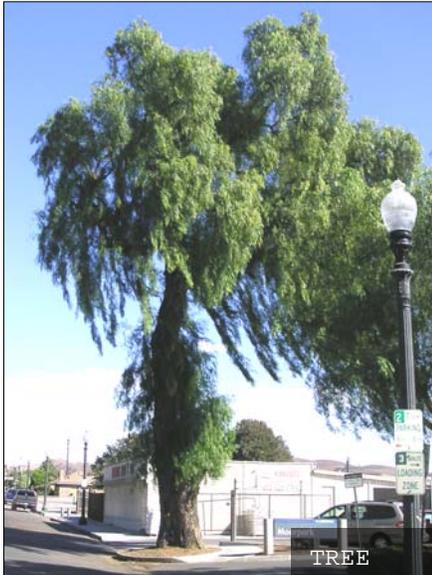
Tag/site #26 This 52-inch diameter tree is growing in a modified typically restricted growing space – the planter pops out into the roadway a distance of about 4 feet. The tree has a canopy that extends about 45 feet high and 43 feet wide. Previous assessments indicate extreme problems with trunk stability and scaffold limb stability. Due to conditions of instability that cannot be mitigated the tree should be removed at the earliest opportunity and the site should be studied for its appropriateness as a designated tree site or a site designated as part of the historic California Pepper grove. If it is determined that replanting is appropriate a new tree may be installed at this location. Please see planting specifications, enclosed.

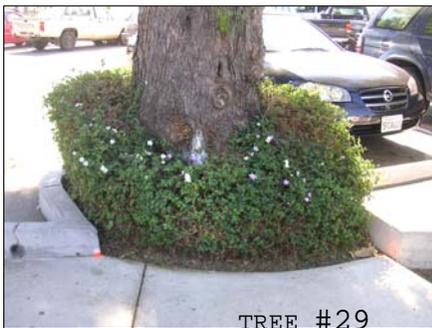
Tag/site #29 This 33-inch diameter tree is growing in a modified typically restricted growing space – the space is a 5-foot by 5-foot planter and the tree's trunk is approximately 1-foot away from the paving in each direction. The tree has a canopy that extends about 35 feet high and 39 feet wide. Previous assessments indicate extreme problems with trunk stability and scaffold limb stability. Due to conditions of instability that cannot be mitigated the tree should be removed at the earliest opportunity and the site should be studied for its appropriateness as a designated tree site or a site designated as part of the historic California Pepper grove. If it is determined that replanting is appropriate a new tree may be installed at this location.

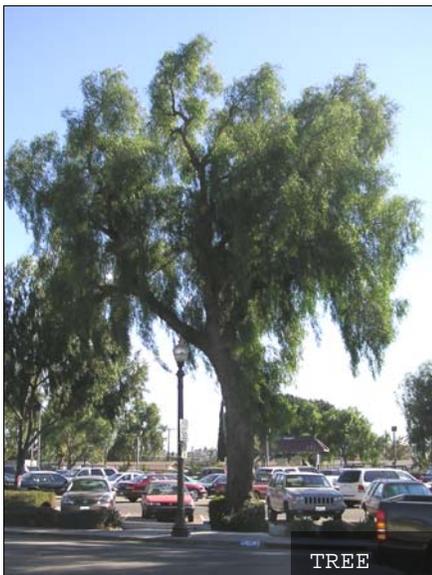
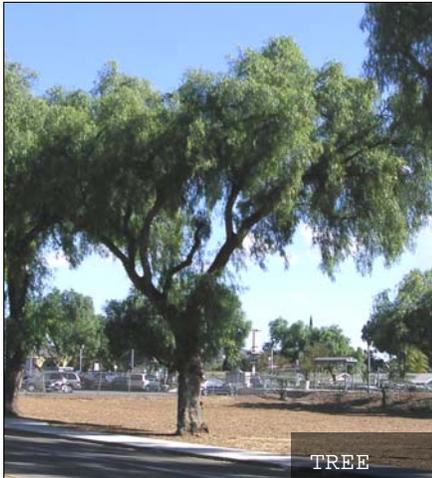
Tag/site #34 This 29-inch diameter tree is growing in a typically unrestricted growing space with a monolithic sidewalk and curb/gutter. The tree has a canopy that extends about 30 feet high and 46 feet wide. Previous assessments indicate extreme problems with root stability and major problems with trunk health and stability and scaffold limb health and stability. Due to conditions of instability and extensive health challenges the tree should be removed at the earliest opportunity, the site should be prepared for replanting and a new tree should be installed at this location. Please see planting specifications, enclosed.

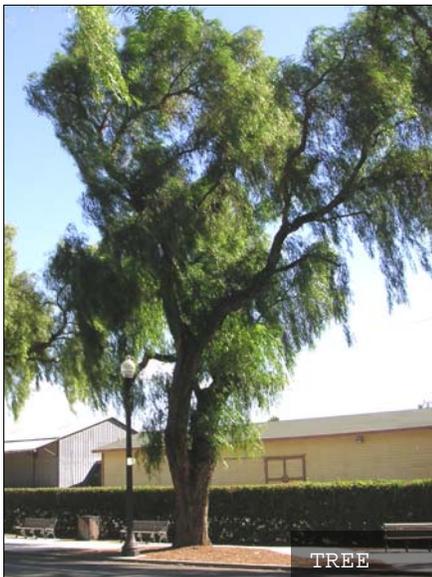
Tag/site #45 This 35-inch diameter tree is growing in a typically unrestricted growing space with a meandering sidewalk and concrete pads with park benches a short distance from the tree base on both the east and west sides. In addition, high voltage utility power lines that run along the south side of the tree. The tree has a canopy that extends about 45 feet high and 45 feet wide. Previous assessments indicate extreme problems with trunk stability and major problems with scaffold limb stability. Due to conditions of instability the tree should be removed at the earliest opportunity, the site should be prepared for replanting and a new tree should be installed at this location. Please see planting specifications, enclosed.
