PRELIMINARY TREE REPORT

Everett Street Terraces Apartments
Moorpark, CA

Date: October 6, 2005

LNDG Project No.: 2270-01

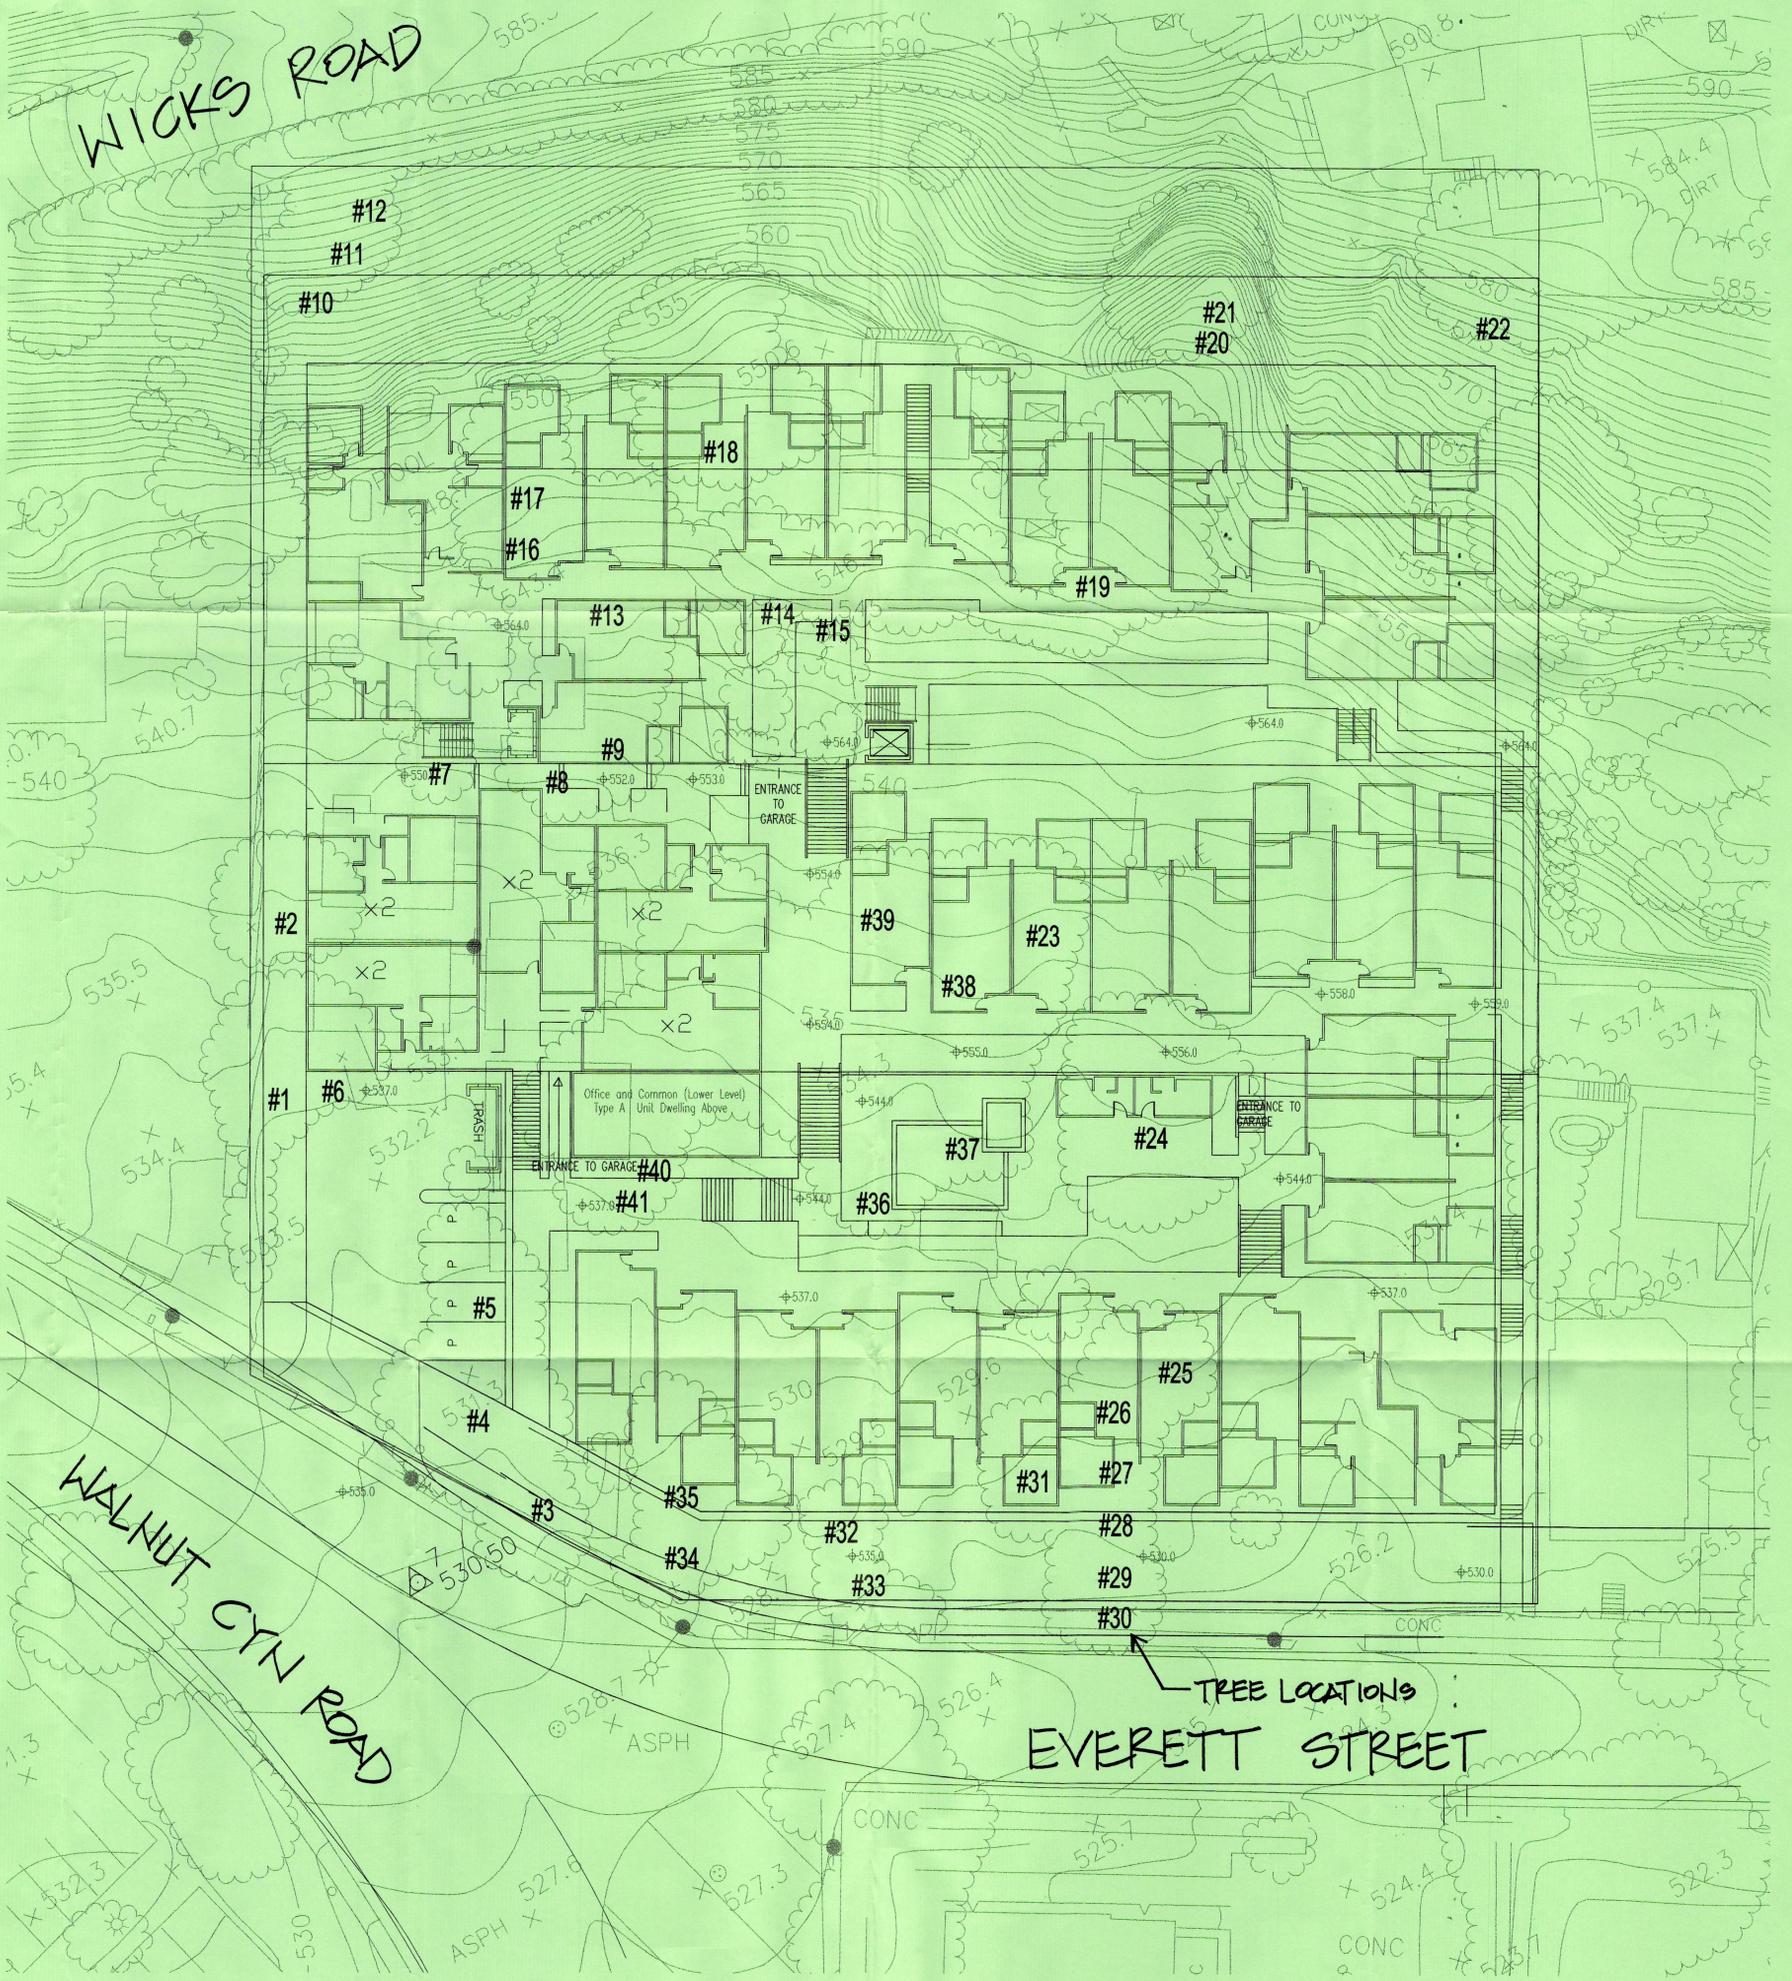
Tree Location Map

All of the inventoried trees were located on a topographic map/site plan (scale: 1/16"=1'-0") that was prepared by Stantec, Inc. Refer to the TREE LOCATION MAP included herein for the approximate tree locations.
