CALIFORNIA PEPPER TREES MAINTENANCE PLAN
HIGH STREET - MOORPARK, CALIFORNIA

1.1 SCOPE

This tree maintenance plan addresses a discrete collection of 50 California Pepper trees (*Schinus molle*) growing in portions of the public right-of-way along East High Street from its intersection with Moorpark Avenue to the 400 block of East High Street in Moorpark, California. Several of the trees may be remnants of an original planting at this location in the year 1900 by Robert Poindexter, a city founding father. The trees are included in Ventura County's Historical Landmark List. The purpose of this maintenance plan is to provide a realistic framework to accomplish an apparent dichotomy of needs: sustain the legacy of the original trees and deliver appropriate care to maximize the benefits of boulevard shade trees while minimizing increased risk to people and property as a result of their presence in this vital city corridor.

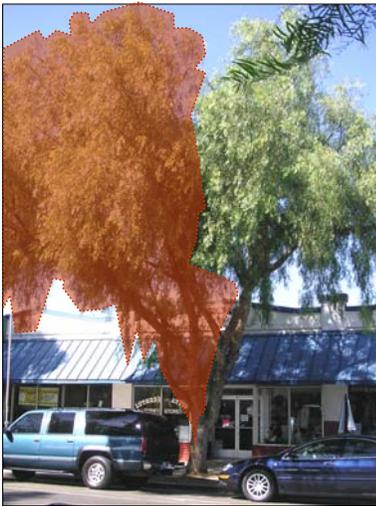
First scenario

'The shade tree tagged #12 in front of the Cactus Patch Restaurant at 197 E. High Street is significantly damaged when a cement truck traveling westbound drifts too close to the pedestrian right-of-way and strikes the tree.' 'The impact breaks two-thirds of the canopy away (red-shaded area in the picture, left).' 'The remaining portion leans over the restaurant at an extreme angle, and a large wound remains in the stem where the broken portion was torn away.' 'Conditions might even be so extreme that, in order to protect public health and welfare a determination is made by safety officers that the remaining portion of the tree should be removed immediately.' 'If it is apparent that the scene can be secured temporarily, a qualified arborist is summoned to inspect the tree, provide an evaluation, and prepare a written report.' 'It is likely that the arborist will condemn this tree due to the severity of the damage inflicted to the otherwise healthy shade tree, and the site would be prepared for a replacement California pepper tree.'

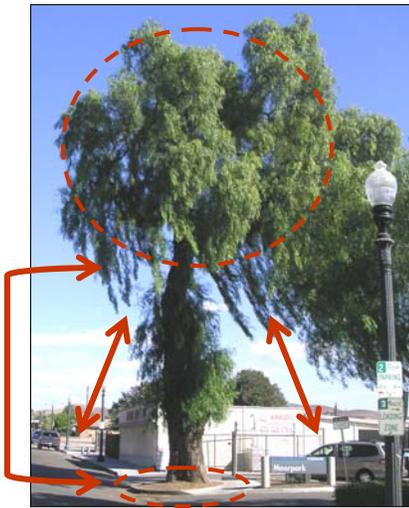
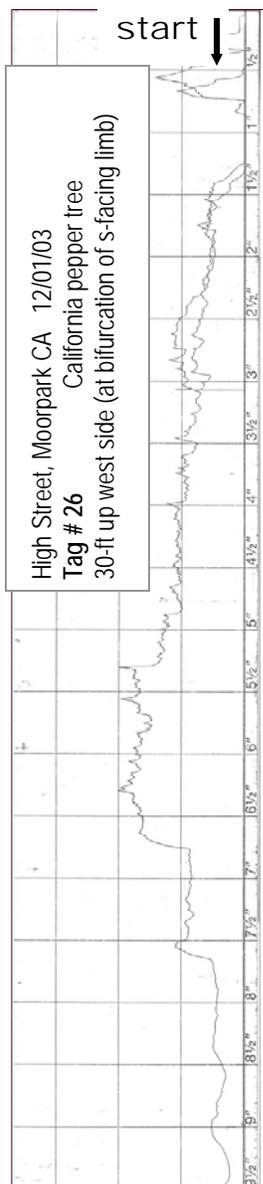
Second scenario

'The large old pepper tree tagged #26 is situated in a very restrictive planter abutting the parking lot entry to Kahoots Feed & Supply at 360 E. High Street.' 'An entry

into the adjacent parking lot at the Moorpark METROLINK Station also abutts the restrictive planter.’ ‘Several inspections and evaluations have been conducted on the tree, including the recent inspection in December 2000 by a qualified consulting arborist, when the tree was noted as having a HIGE FAILURE POTENTIAL.’ ‘The hazard rating system utilized in 2000 was based on methodology contained in A Photographic Guide to the Evaluation of Hazard Trees in Urban Areas by Matheny and Clark.’ ‘Another recent inspection provided in August 2003 was more general, but it called for an additional assessment process utilizing special instruments and analysis.’

‘In December 2003 an indepth report was prepared by another qualified consulting arborist, using a Resistograph – an instrument specifically designed and manufactured to determine the relative degree of decay in internal woody tissues and producing a wax strip that displays the results of the measurement.’ ‘Assessment criteria recommended by the Council of Tree and Landscape Appraisers, which includes a thorough assessment of five attribute categories (roots, stem, major limbs, minor limbs, and foliage), and employing a rating methodology, was also used to describe and characterize biological health and mechanical stability of the tree.’ ‘When employed by a qualified diagnostition, as performend here, both the instrument and analysis methology provide a very comprehensive evaluation of the tree.’ ‘Findings conveyed in the assessment report indicated that the tree was senescent and should be removed.’

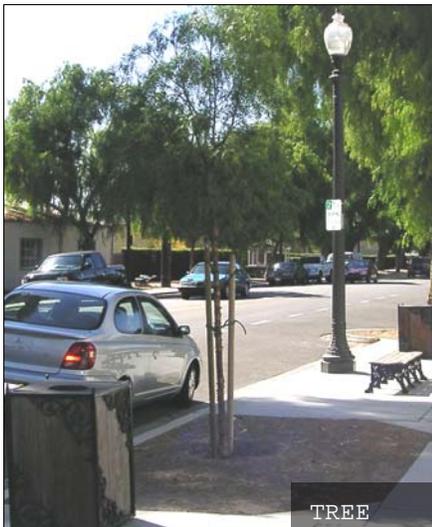
Tag/site #15 This 2.5-inch caliper newly installed tree is growing in a typically restricted growing space. It is staked with double stakes. The tree has not yet established. Monitor the tree's progress; provide supplemental irrigation on a regular basis; trim the tops of the stakes away from lower branches (cut the stakes – not the branches) and remove the stakes and ties as soon as it is determined that the tree can stand unaided; avoid removing any live foliage until expansion of the canopy intensifies.

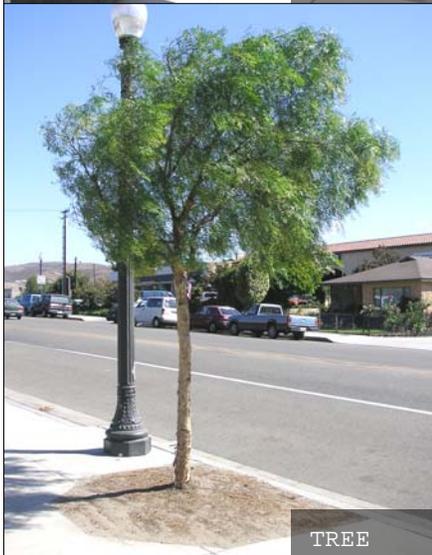
Tag/site #25 This 4-inch diameter tree is growing in a typically restricted growing space. The tree is becoming established. Monitor the tree's progress; provide supplemental irrigation as needed; provide routine pruning techniques as needed, direct the development of temporary major scaffold limbs on an east/west axis, prune to thin foliage on heavily laden limbs to avoid excessive strain, drooping, and possible breakage, avoid heading-back terminal ends and promote an upward growing canopy architecture, avoid over pruning the tree (remove up to or less than but no more than 20 percent of the live foliage).

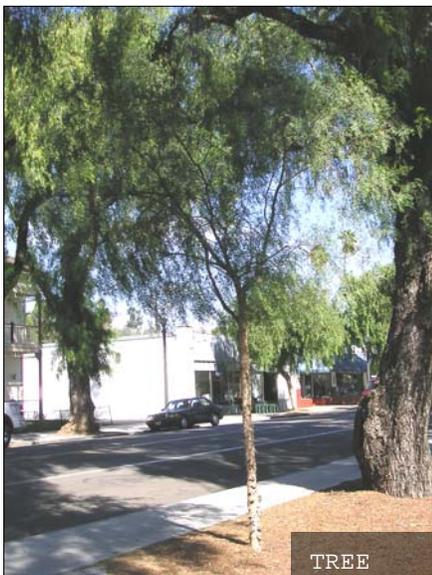
Tag/site #48 This 4-inch diameter tree is growing in a typically unrestricted growing space with a monolithic sidewalk and curb/gutter. The tree is becoming established. Monitor the tree's progress; provide supplemental irrigation as needed; provide routine pruning techniques as needed, direct the development of temporary major scaffold limbs on an east/west axis, thin foliage on heavily laden limbs to avoid excessive strain, drooping, and possible breakage, avoid heading-back terminal ends and promote an upward growing canopy architecture, avoid over pruning the tree (remove up to or less than but no more than 20 percent live foliage).

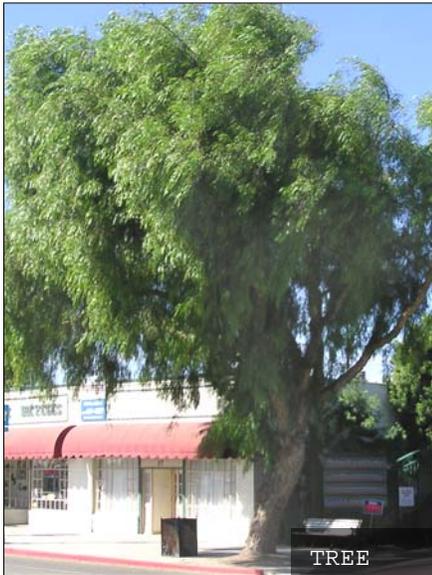
Tag/site #1 This 23-inch diameter tree is growing in a typically restricted growing space with a park-style bench located about 10 feet north of the planting site. The tree has a canopy that extends about 30 feet high and as wide. The main stem leans to the north (away from High Street), but its dense canopy has become reoriented toward the south. Multiple primary scaffold limbs originate from the main stem about 12 feet up from grade. Monitor the tree's stability on a routine basis (at least annually and at times of inclement weather), especially sections that extend over (and therefore tend to threaten) the vicinity of the park bench; provide crown reconstruction pruning techniques to improve scaffold branch attachment and arrangement, provide routine pruning techniques as needed, prune to maintain adequate clearance for vehicular traffic on High Street and pedestrian traffic along the sidewalk, prune to thin foliage on heavily laden limbs to avoid excessive strain, drooping, and possible breakage, avoid heading-back terminal ends and promote an upward growing canopy architecture, avoid over pruning the tree if possible but take necessary steps to redirect canopy development while maintaining tree health.

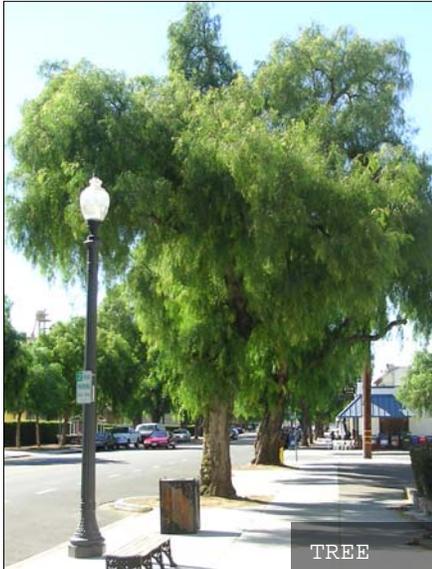
Tag/site #14 This 25-inch diameter tree is growing in a modified typically restricted growing space – the planter pops out into the roadway a distance of about 4 feet. The tree has a canopy that extends about 20 feet high and as wide. Multiple primary scaffold limbs originate from the main stem about 12 feet up from grade and support a dense, asymmetrical canopy. Monitor the tree's stability

on a routine basis; provide crown reconstruction pruning techniques to improve scaffold branch attachment and arrangement, provide routine pruning techniques as needed, prune to provide adequate clearance for vehicular traffic on High Street and pedestrian traffic along the sidewalk, prune to thin foliage on heavily laden limbs to avoid excessive strain, drooping, and possible breakage, avoid heading-back terminal ends and promote an upward growing canopy architecture, avoid over pruning the tree if possible but take necessary steps to redirect canopy development while maintaining tree health.

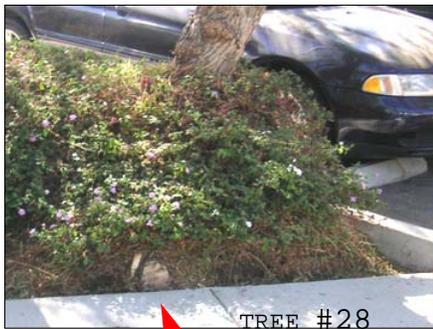
Tag/site #28 This 11-inch diameter tree is growing in an atypical growing space that is 9 feet wide but the trunk is only 1 foot west and 2 feet south of pavement edges. Large surface roots (6-inches in diameter and 4-inches in diameter – see detail photo) have been cut on the north side, behind the direction of the tree's lean, to avert encroachment with adjacent pavement. This treatment tends to destabilize the tree. The tree has one low horizontal scaffold limb extending to the south; its canopy, 20-foot high and as wide, is otherwise symmetrical. Monitor the tree's stability on a routine basis, especially sections that extend over (and therefore tend to threaten) the vicinity of the parking lot; provide pruning treatments to remove the low branch and

improve the branch distribution, provide routine pruning techniques as needed, prune to provide adequate clearance for vehicular and pedestrian traffic, prune to thin foliage on heavily laden limbs to avoid excessive strain, drooping, and possible breakage, avoid heading-back terminal ends and promote an upward growing canopy architecture, avoid over pruning the tree if possible but take necessary steps to redirect canopy development while maintaining tree health. When the opportunity arises to replace the tree the new specimen should be centered in the growing space.

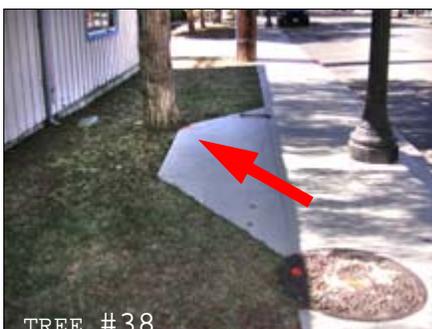
Tag/site #38 This 14-inch diameter tree is growing in an atypical growing space that is 5 feet deep – the tree trunk abuts a sidewalk section extended into the planter to accommodate an ornamental street lamppost. Imminent conflict is likely with the adjacent meandering sidewalk. Monitor the tree's stability and its impact on adjacent structure and infrastructure; provide routine pruning techniques as needed, prune to maintain adequate clearance for vehicular and pedestrian traffic and clearance from the building roof, prune to thin foliage on heavily laden limbs to avoid excessive strain, drooping, and possible breakage, avoid heading-back terminal ends and promote an upward growing canopy architecture, avoid over pruning the tree (remove up to or less than but no more than 20 percent of the live foliage). When an opportunity arises to replace the tree the new specimen should be accommodated by the growing space.

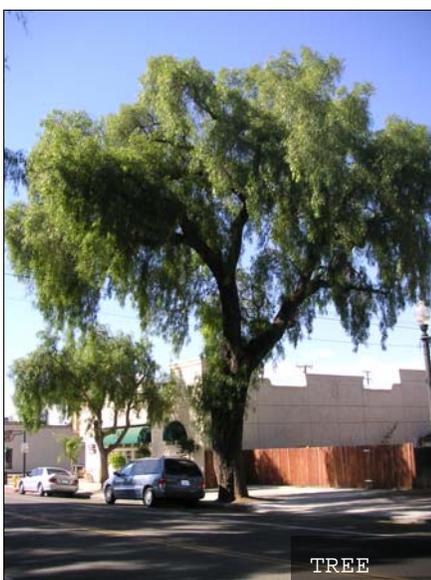
Tag/site #49 This 51-inch diameter tree is growing in a typically unrestricted growing space with a monolithic sidewalk and curb/gutter. The tree's canopy extends about 50 feet high and 70 feet wide. Three primary scaffold limbs bifurcate from the stem about 6 feet above grade and triangulate in such a fashion as to avoid the vicinity of power lines that run along the south side of the tree. A utility pole and associated communications lines are located beneath and extending through the canopy; this infrastructure has minor relevance to tree maintenance. Monitor the tree's stability on a routine basis; provide crown reconstruction pruning techniques along the long horizontal limbs to promote branch development and architectural structure closer toward the main stem, provide routine pruning techniques as needed, prune to maintain adequate clearance for vehicular traffic on High Street, prune to thin foliage on heavily laden limbs to avoid excessive strain, drooping, and possible breakage, routinely reduce horizontal canopy expansion by selectively cutting back terminal ends to appropriate-sized and well-placed lateral branches, avoid over pruning the tree (remove up to or less than but no more than 20 percent of the live foliage).

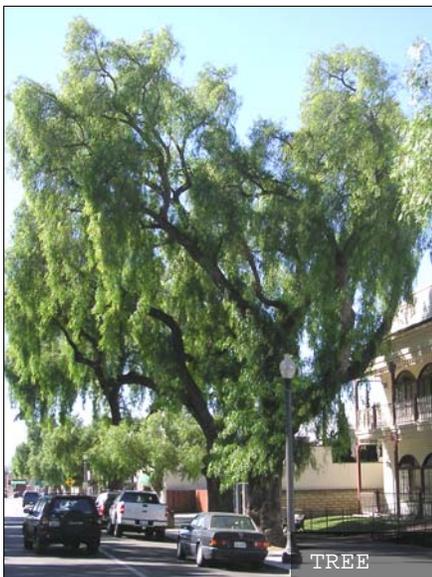
Tag/site #9 This 40-inch diameter tree is growing in a typically restricted growing space. In addition to paving/surface restrictions the tree is situated in close proximity to the adjacent tree (#8); they were planted 20 feet on center. Allowing for reasonable canopy extension and healthy long-term development, a minimum specification for trees this size should be 30 feet on center. Previous assessments indicate extreme problems with trunk stability and major problems with both the health of scaffold limbs and smaller branches and twigs. The tree's canopy extends about 55 feet high and 60 feet wide. The initial stem bifurcation is about 10 feet up, progressive branching of secondary scaffold limbs occurs throughout the canopy producing an extensive canopy architecture. Most or all of the scaffold limbs are long and horizontal and tend to be heavily loaded toward branch ends. Initiate extensive crown reconstruction pruning on an annual schedule for a minimum of 5 years; progressively reduce the length of long vertical and horizontal limbs each year to gradually promote branch development and architectural structure closer toward the main stem, delay other routine pruning techniques until crown reconstruction is well underway, safety prune to maintain adequate clearance for vehicular traffic on High Street and pedestrian traffic along the sidewalk

but, over time, develop well placed new sprouts to extend canopy architecture lower on the stem.

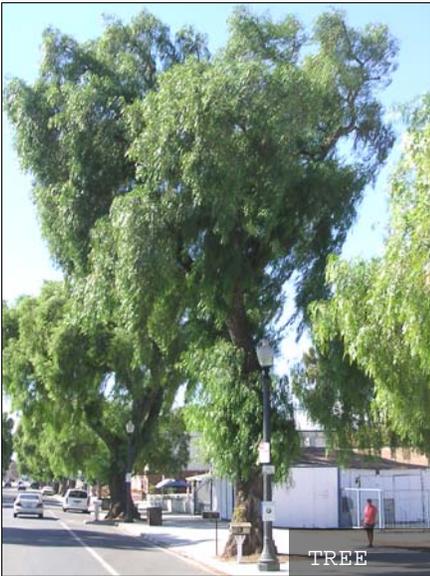
Tag/site #23 This 40-inch diameter tree is growing in a typically restricted growing space. Previous assessments indicate major problems with the stability of the trunk and the scaffold limbs. The tree's canopy extends about 40 feet high and 44 feet wide. This tree has co-dominant stem architecture and initial stem bifurcation occurs about 8 feet up. Lateral secondary scaffold limbs occur high in the canopy resulting in canopy architecture exerting severe leverage on weakened primary structure elements. Initiate extensive crown reconstruction pruning on an annual schedule for a minimum of 5 years; progressively reduce the length of long vertical and horizontal limbs each year to gradually promote branch development and architectural structure closer toward the main stem, delay other routine pruning techniques until crown reconstruction is well underway, safety prune to maintain adequate clearance for vehicular traffic on High Street and pedestrian traffic along the sidewalk but, over time, develop well placed new sprouts to extend canopy architecture lower on the stem.

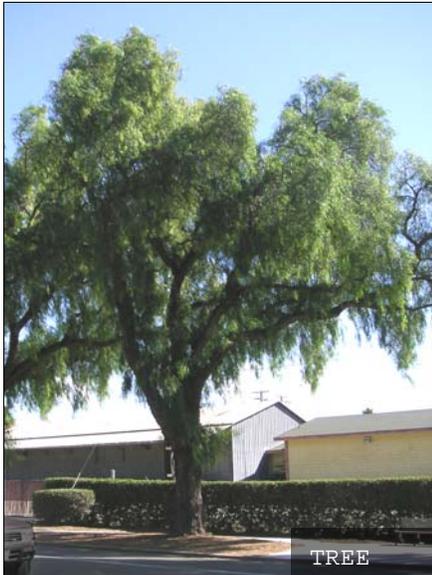
Tag/site #44 This 33-inch diameter tree is growing in a typically unrestricted growing space with a meandering sidewalk, placing the tree in an open space between the

sidewalk and High Street. A potential aerial conflict exists with high voltage utility power lines that run along the south side of the tree. Previous assessments indicate extreme problems with scaffold limb stability, and major problems with trunk stability and scaffold limb health. The tree bifurcates at about 10 up with 3 primary scaffolds, progressive branching of secondary scaffold limbs occurs producing an extensive canopy supported by long lateral limbs that tend to be heavily loaded toward branch ends. Initiate extensive crown reconstruction pruning on an annual schedule for a minimum of 5 years; progressively reduce the length of long vertical and horizontal limbs each year to gradually promote branch development and architectural structure closer toward the main stem, delay other routine pruning techniques until crown reconstruction is well underway, safety prune to maintain adequate clearance for vehicular and pedestrian traffic but, over time, develop well placed new sprouts to extend canopy architecture lower on the stem.
